FILAMENT COMPOSITE MATERIAL LANDING
GEAR PROGRAM, VOLUME I

Bendix Corporation

Air Force Flight Dynamics Laboratory

AFFDL TR 72-78, Vol. I

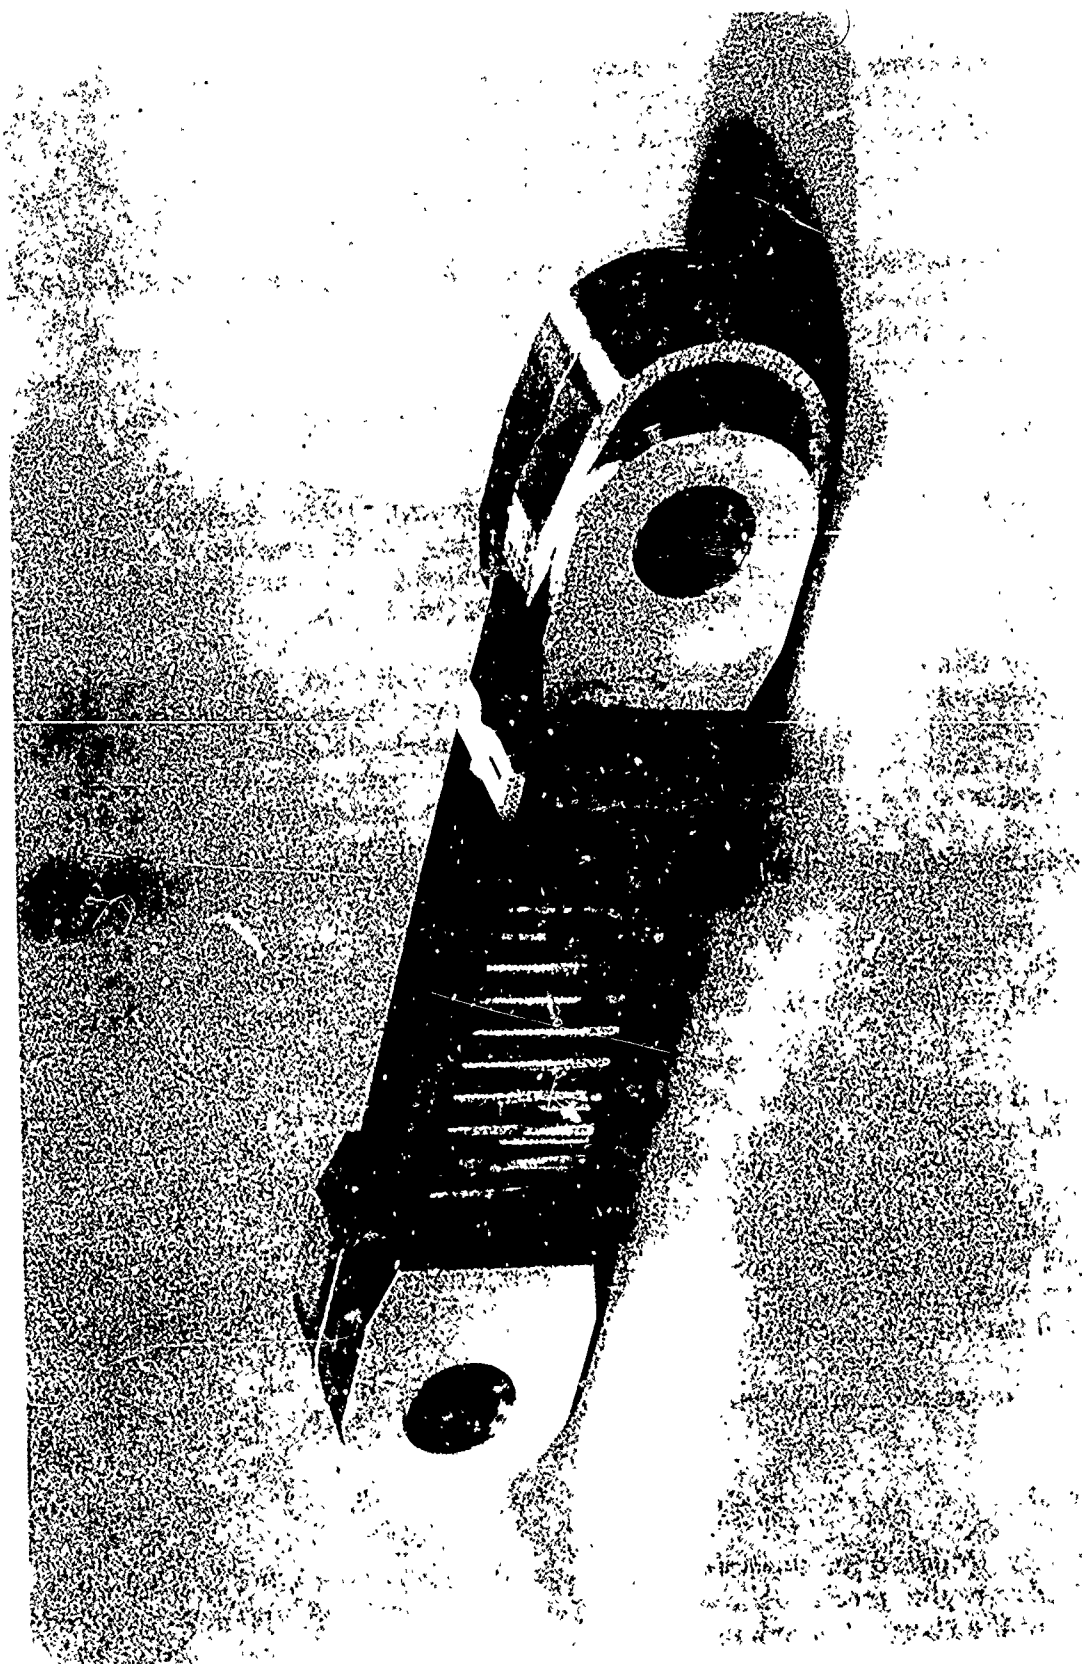
Figure 5-45. Failed Boron-Epoxy Side Brace Specimen

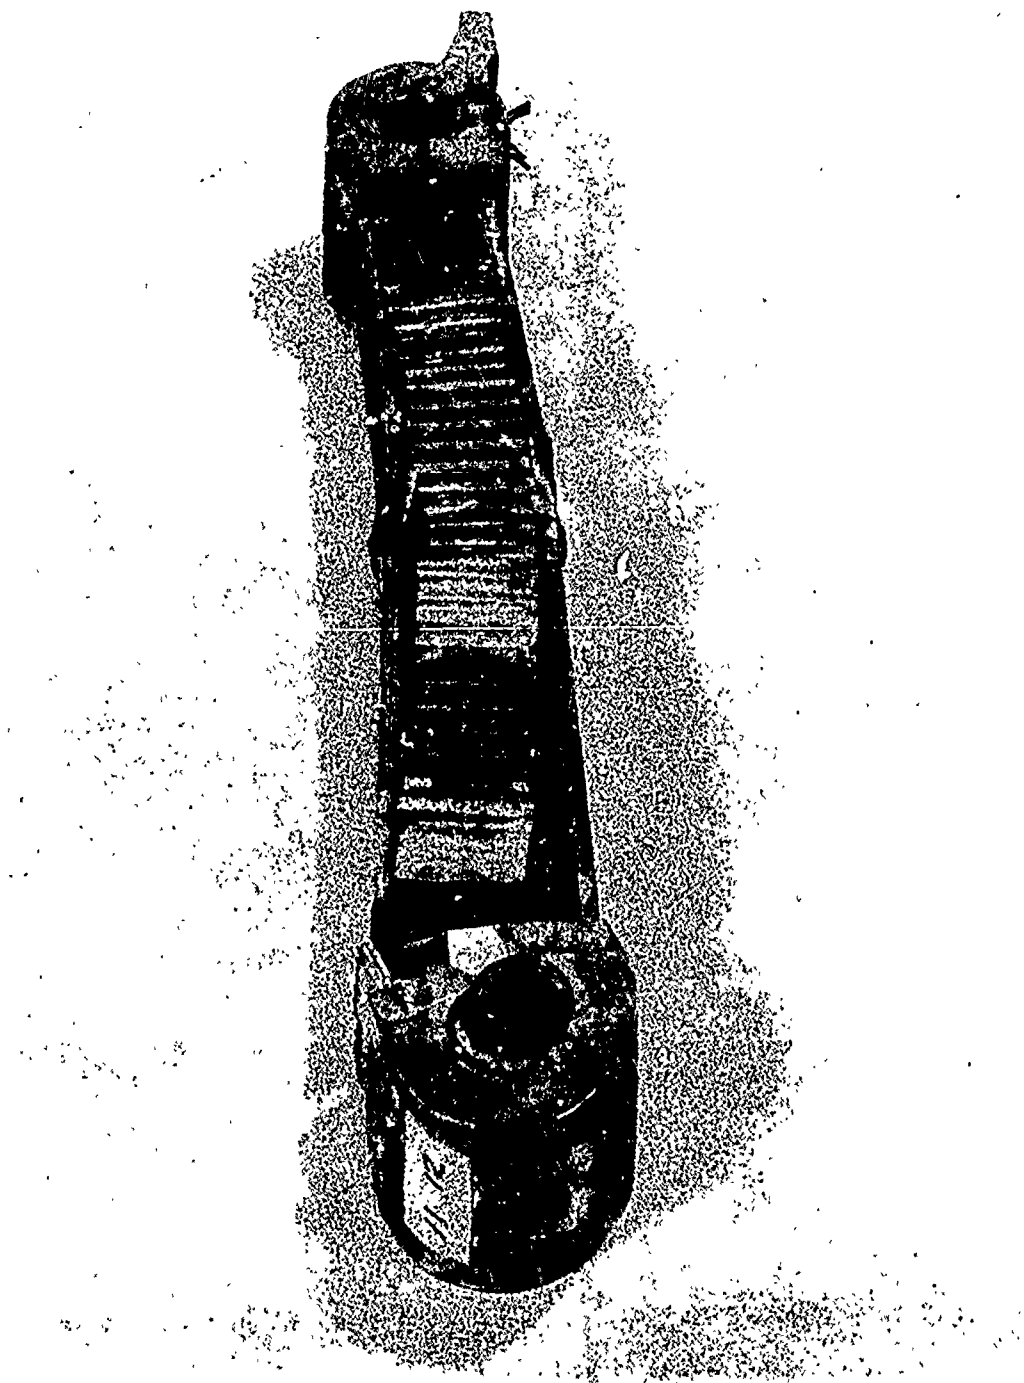
Compression Load - The link was loaded continuously until failure occurred at 23000 pounds (115 percent limit load). The failed part is illustrated in Figure 7-32. The failure appeared to initiate in the metal end fitting as a shear failure and with rupture of the boron composite flange as a secondary failure.

Figure 7-32. Failed Side Brace Lower Link (P-25190U)
